Manhole Inspection Summary

Manhole # S09QQ1009MH

Insp Date: **4/17/07 2:51 PM**

Location Address: **ALLEY OF 3037 BEVEDERE ALLEY SPAULDING**

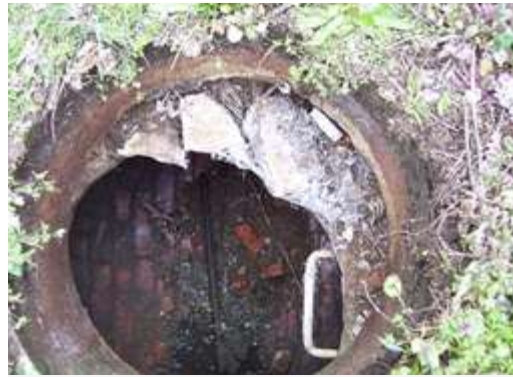
Top View

Offset: **6** (in.)

OFFSET FRAME

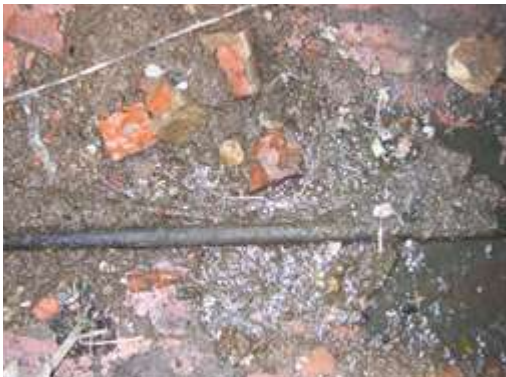
Defect 1

DEBRIS IN CHANNEL

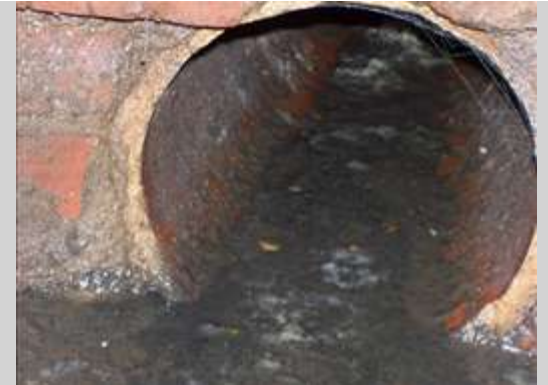
12 O'Clock Outflow

Deposits: ☐ None ☐ Mud ☐ Sludge ☒ **Debris** ☐ Grease

Silt Depth: **0.5** (in.) Deposits Extent: **Light**
